June 8, 2003

## TECHNICAL NOTE 56, EXTRACTOR RELIABILITY

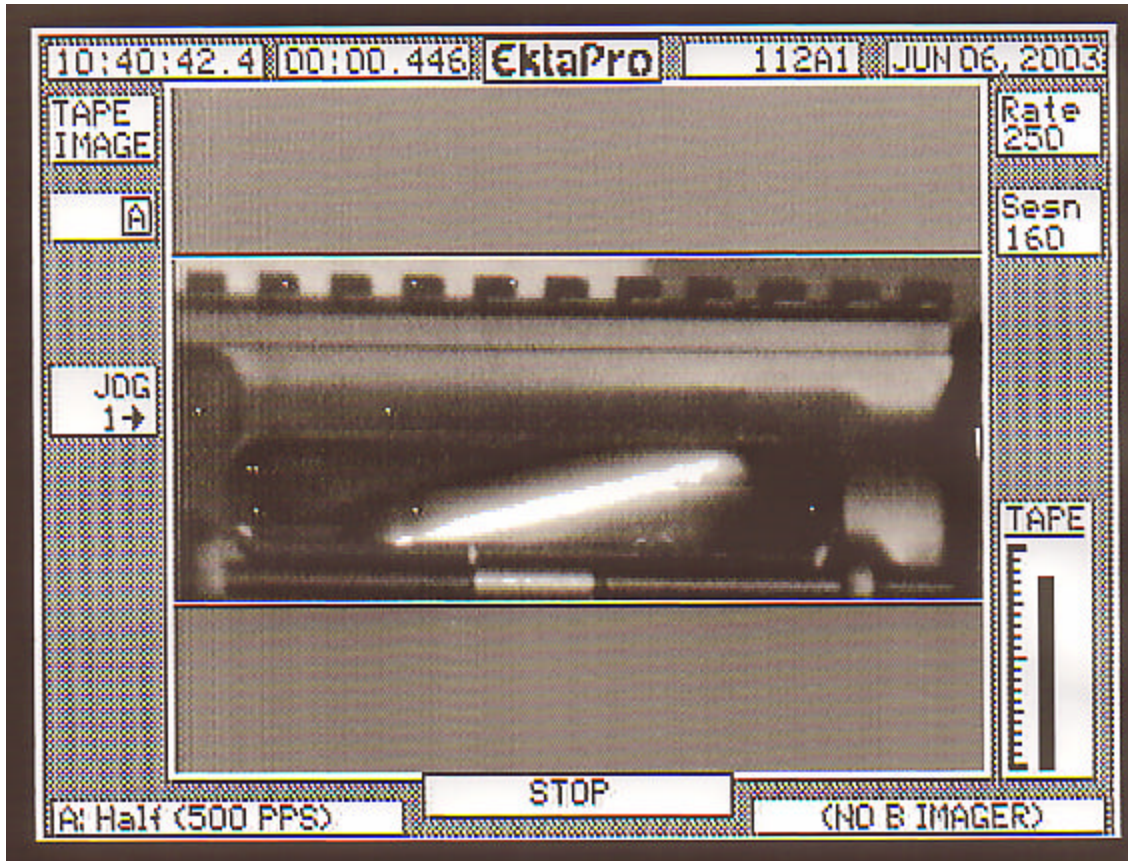
Instead, the case is not ejected from the action and the following round is fed to the chamber. Forward motion of the bolt stops when the fired round stubs between the barrel and bolt face and the next cartridge stops with the bullet tip just inside the chamber mouth (Figure 1). The problem has proved difficult to diagnose because it is infrequent, incorrectly described, and involves a number of subtle causes.

**Figure 1.** Fired cartridge jammed between barrel extension and bolt. Following round (not visible) is feeding into the barrel extension.

**What to do:** Few shooters will ever see this problem, and they don’t need to do anything. Those without the O-ring extractor spring reinforcement should request one and it will be provided at no charge. Shooters suffering this problem should correct the fouling and heating problems noted above, use NATO standard ammunition, and contact ArmaLite for further instructions if the problem continues.

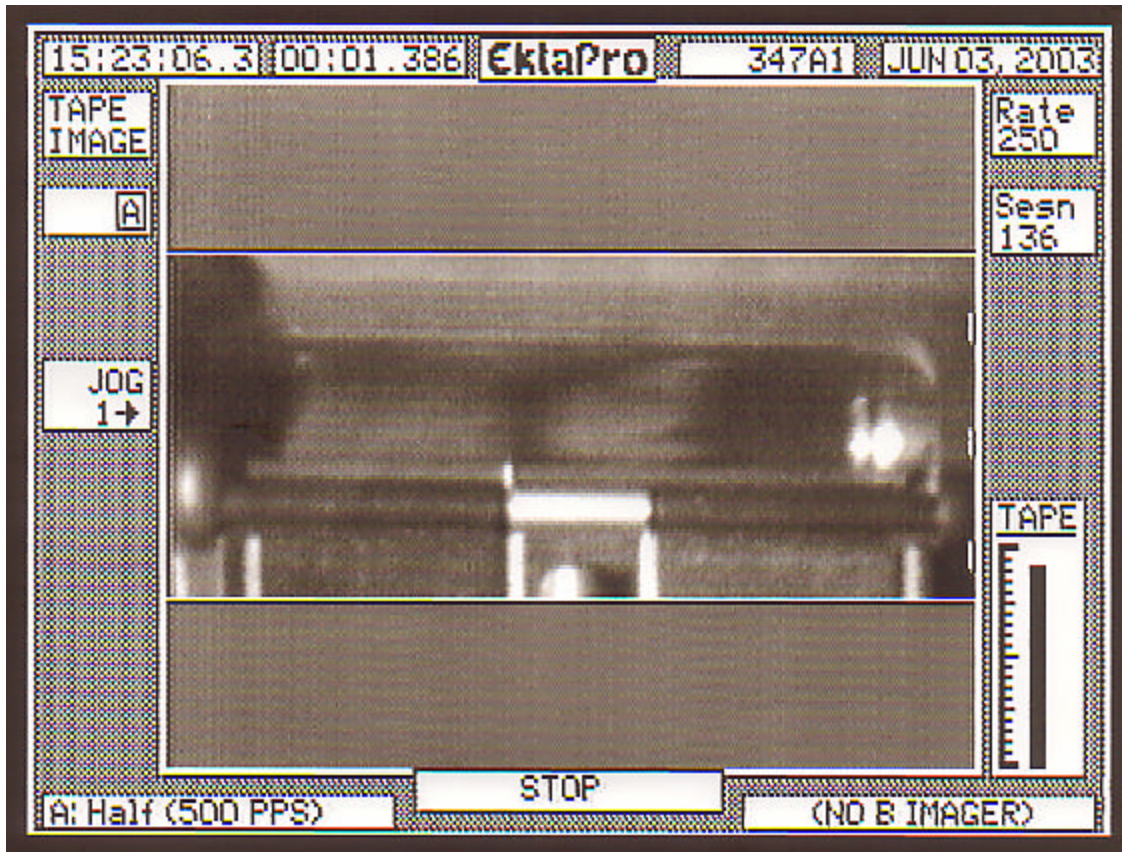
**Findings:** Extensive testing was required to determine that the bolt loses control of the cartridge case very soon after pulling on it strongly enough to mark the rim, but well before the ejector can function. In other words, extraction starts, but doesn’t finish.

**Figure 2.** Bolt is moving to the rear followed by the fired cartridge. The fired cartridge is moving slower than the bolt, and cannot be ejected. Even at 500 frames per second, the bolt movement is blurred by its speed.
